Manhole Inspection Summary

Manhole # S29S1_016MH

Location Address: **1052 Bethune Rd.**

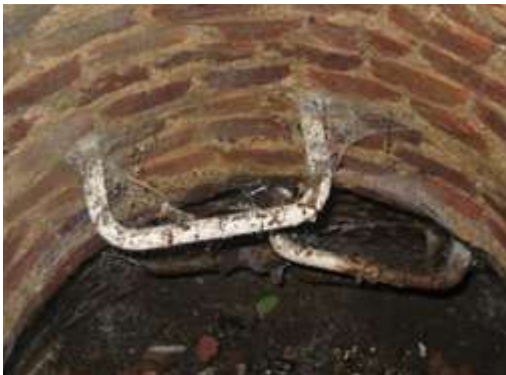
Steps Count: **4** Missing: **0** ☒ **Corroded**

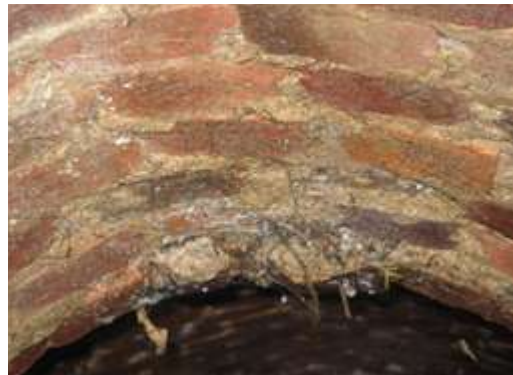
Defect 2

Condition: ☐ Sound ☐ Cracked ☒ **Root Intrusion** ☐ Loose Brick ☐ Deteriorated

Root intrusion.

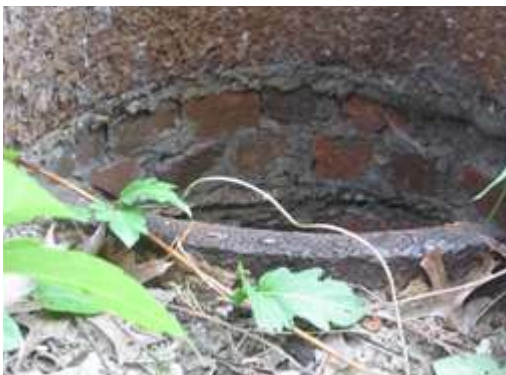
Defect 1

Frame above the grade.

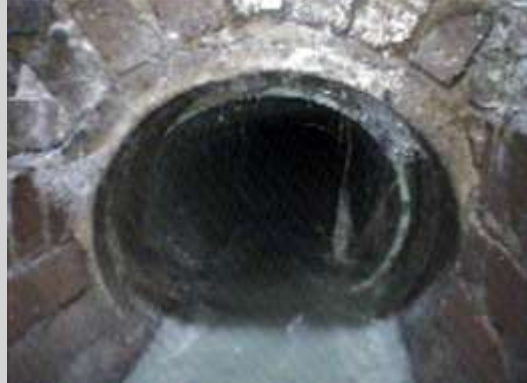
12 O'Clock Outflow

Pipe Height: **14.4** (in.) Rod and Bar (Angled)
Pipe Material: **Clay** ☐ Pipe Lined
Invert Depth: **9.96** (ft.) Flow Characteristics: **Fast**
Deposits: ☒ None ☐ **Mud** ☐ Sludge ☐ **Debris** ☐ Grease
Silt Depth: (in.) Deposits Extent:
Infiltration: **None** Pipe Seal Cond: **Sound**

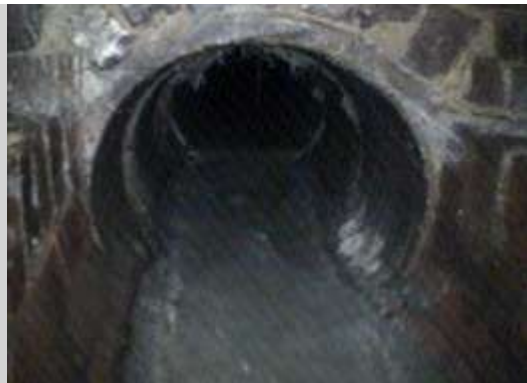
6 O'Clock Inflow

Pipe Height: **8.4** (in.) Rod and Bar (Angled)
Pipe Material: **Clay** ☐ Pipe Lined
Invert Depth: **9.60** (ft.) Flow Characteristics: **Fast**
Deposits: ☒ None ☐ **Mud** ☐ Sludge ☐ **Debris** ☐ Grease
Silt Depth: (in.) Deposits Extent:
Infiltration: **None** Pipe Seal Cond: **Sound**

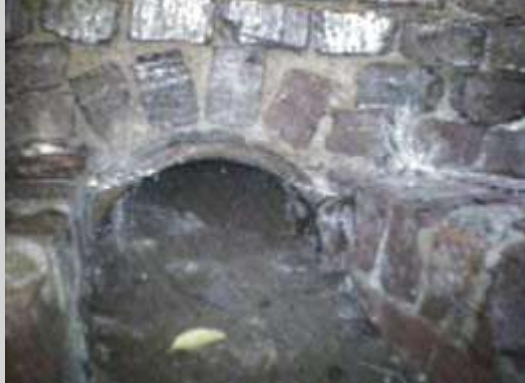
9 O'Clock Inflow

Comments **Influent pipe in @ 9 O'Clock could not be accurately measured due to pipe deposits.**

Deposits: ☐ None ☒ **Mud** ☐ Sludge ☒ **Debris** ☐ Grease

Silt Depth: **5** (in.) Deposits Extent: **Heavy**
